# Manhole Inspection Summary

Manhole # S39K\_\_021MH

Insp Date: **8/20/08 12:39 PM**

**Location** Address: **pier 5**

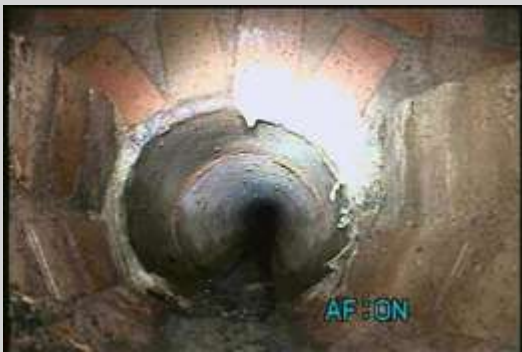
12 O'Clock Outflow

8 in. Circular Gravity Sewer  
Pipe Out @ 12 O'Clock

Pipe Material: **Clay** ☐ Pipe Lined

Invert Depth: 7.50 (ft.) Flow Characteristics: **Slow**

Deposits: ☒ None ☐ Mud ☐ Sludge ☐ **Debris** ☐ Grease

Infiltration: **None** Pipe Seal Cond: **Unknown**

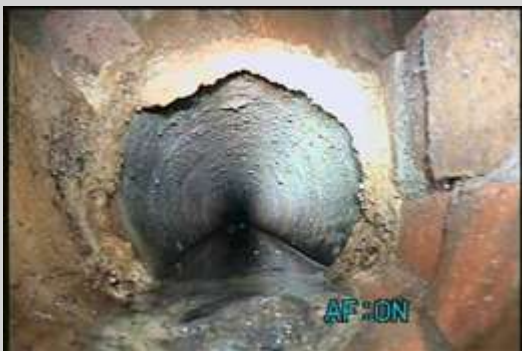
5 O'Clock Inflow

8 in. Circular Gravity Sewer  
Pipe In @ 5 O'Clock

Pipe Material: **Clay** ☐ Pipe Lined

Infiltration: **None** Pipe Seal Cond: **Unknown**
